Dalvegur

| Reflex Arkitekter |
| PG-Verk |
| 7 November 2022 |

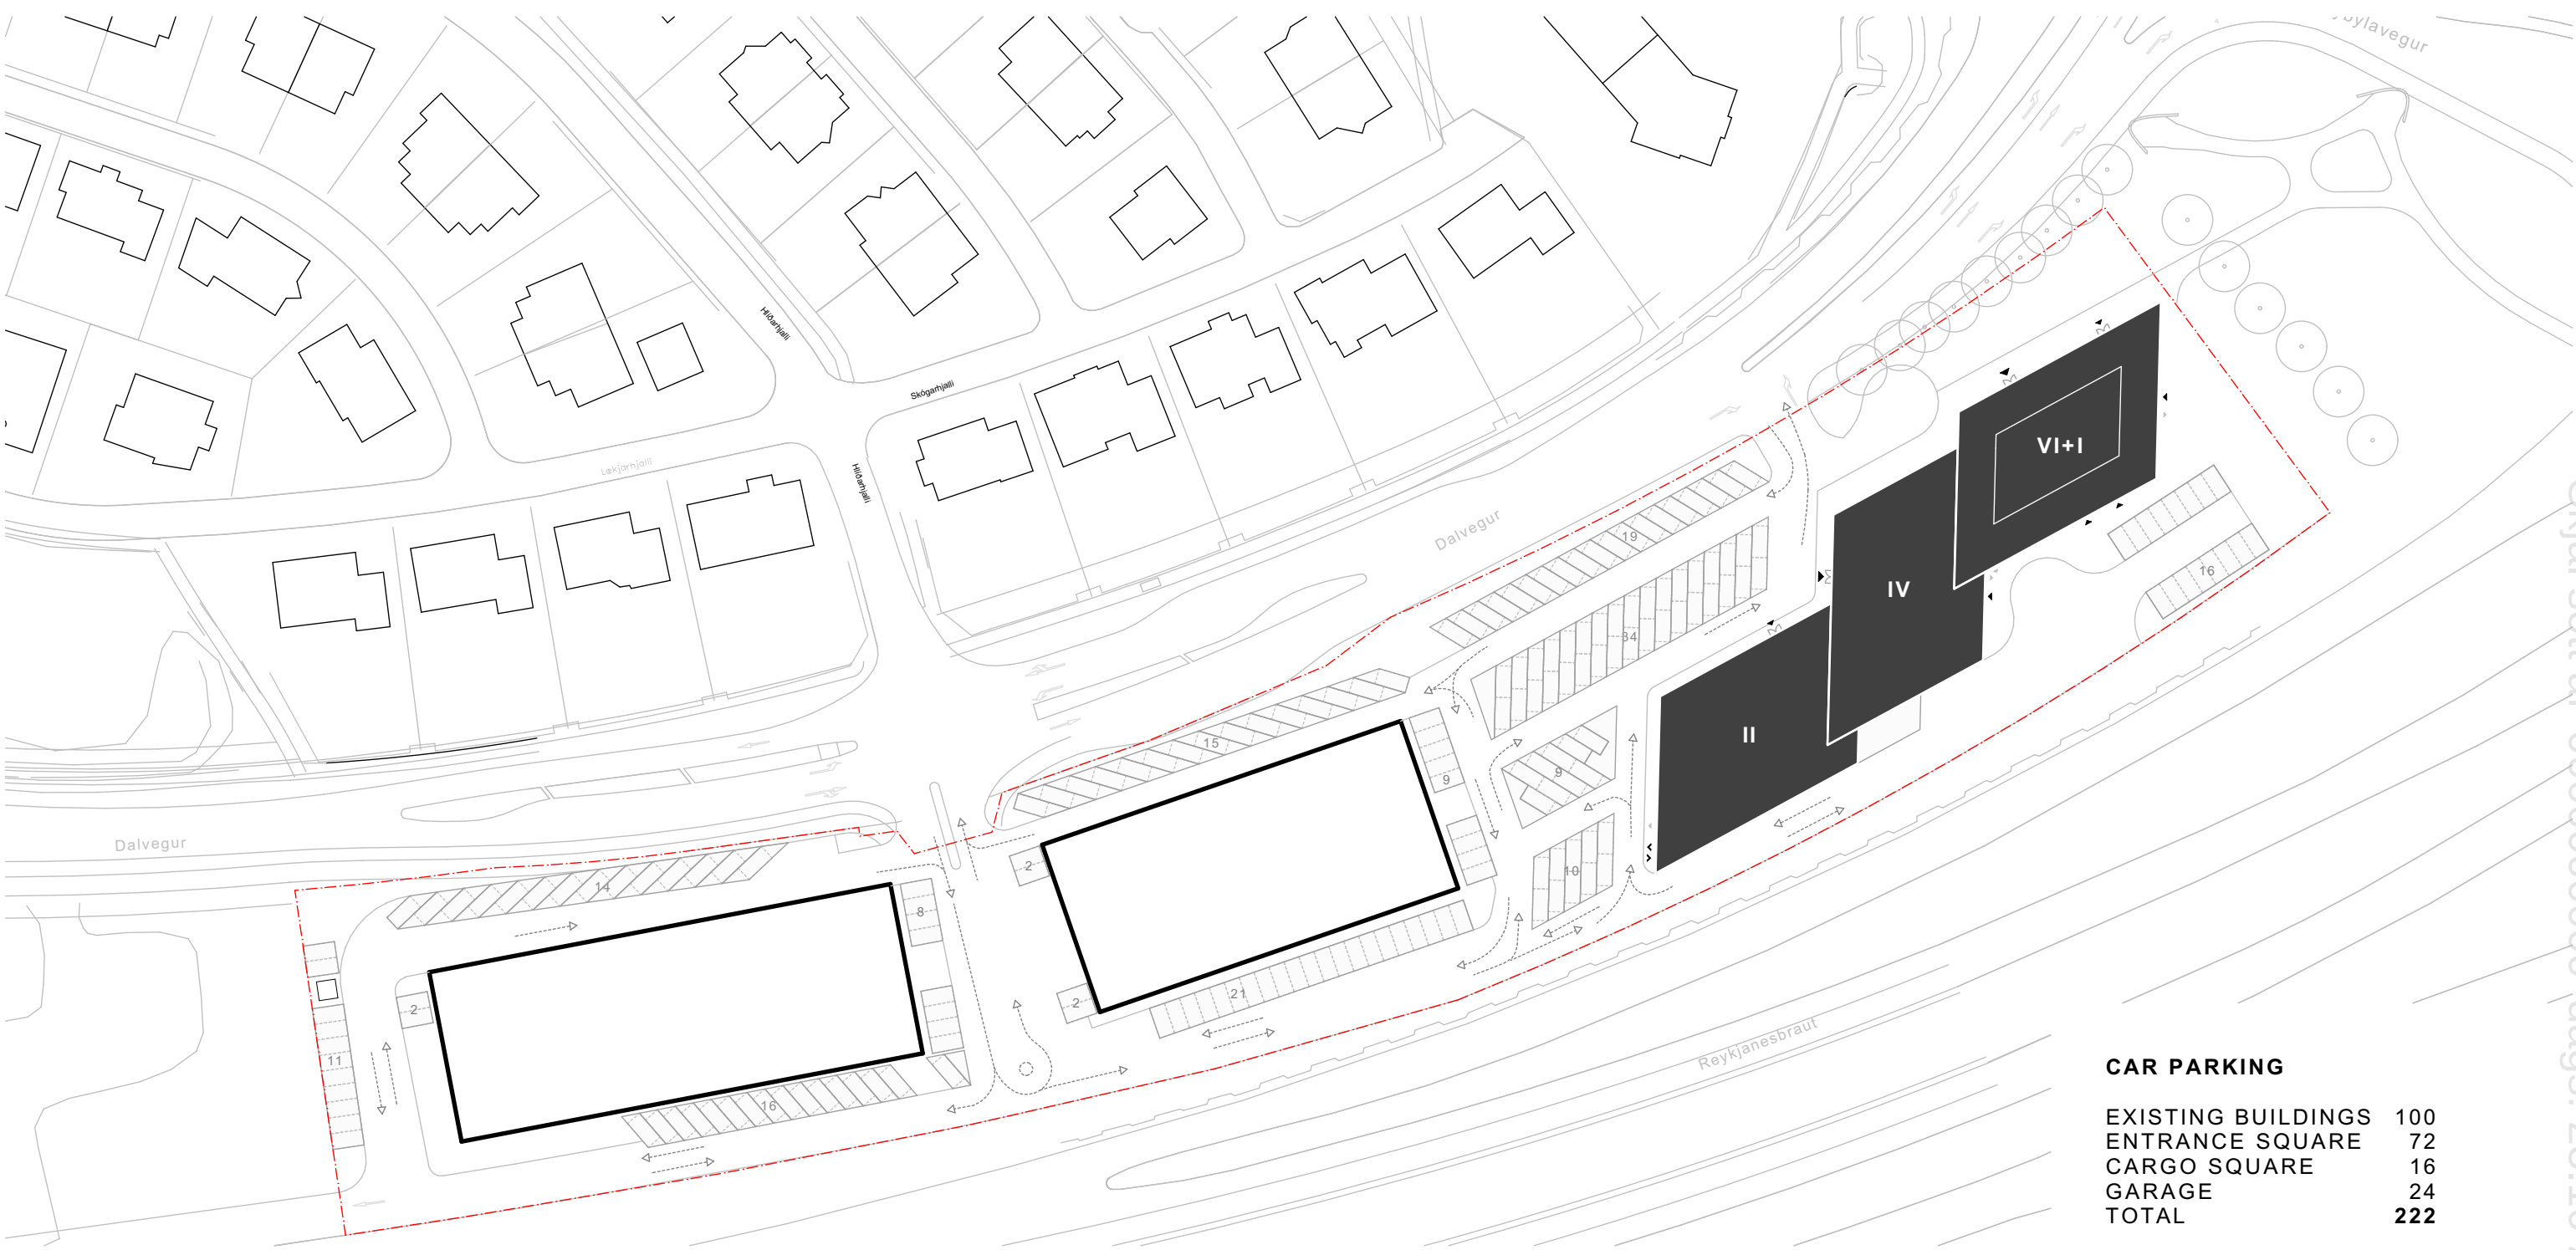
| CAR PARKING | |
| EXISTING BUILDINGS | 100 |
| ENTRANCE SQUARE | 72 |
| CARGO SQUARE | 16 |
| GARAGE | 24 |
| TOTAL | 222 |

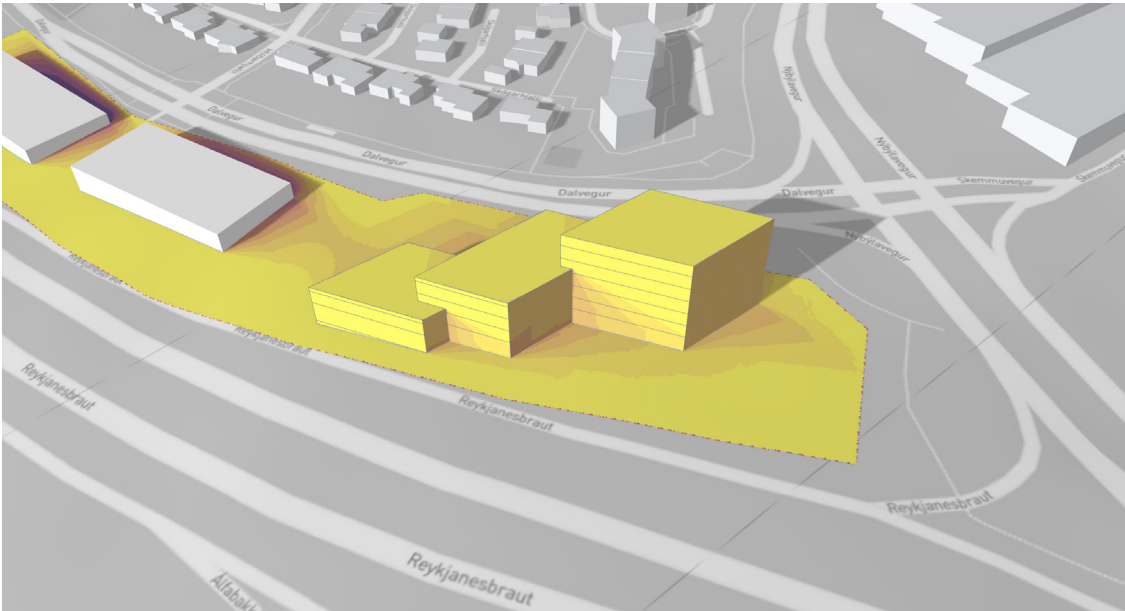
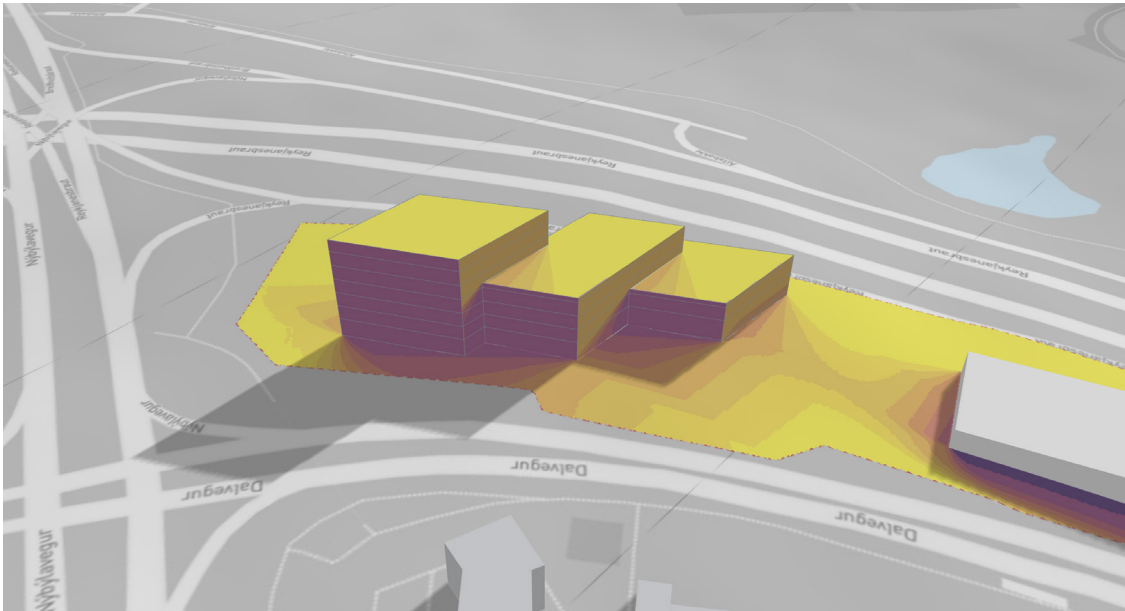
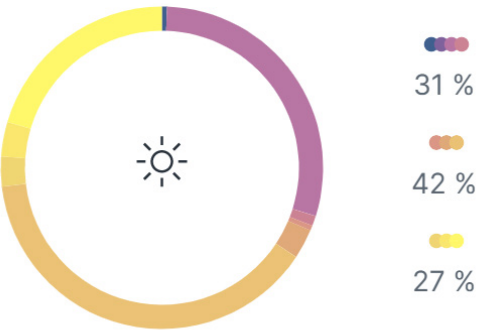
March 21

Solar analysis

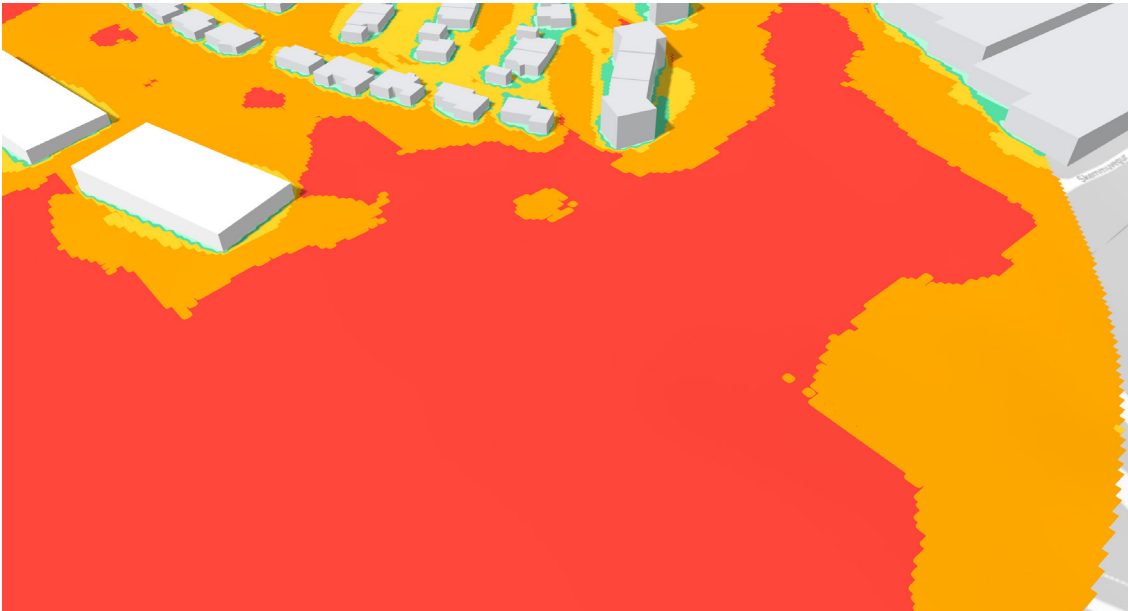
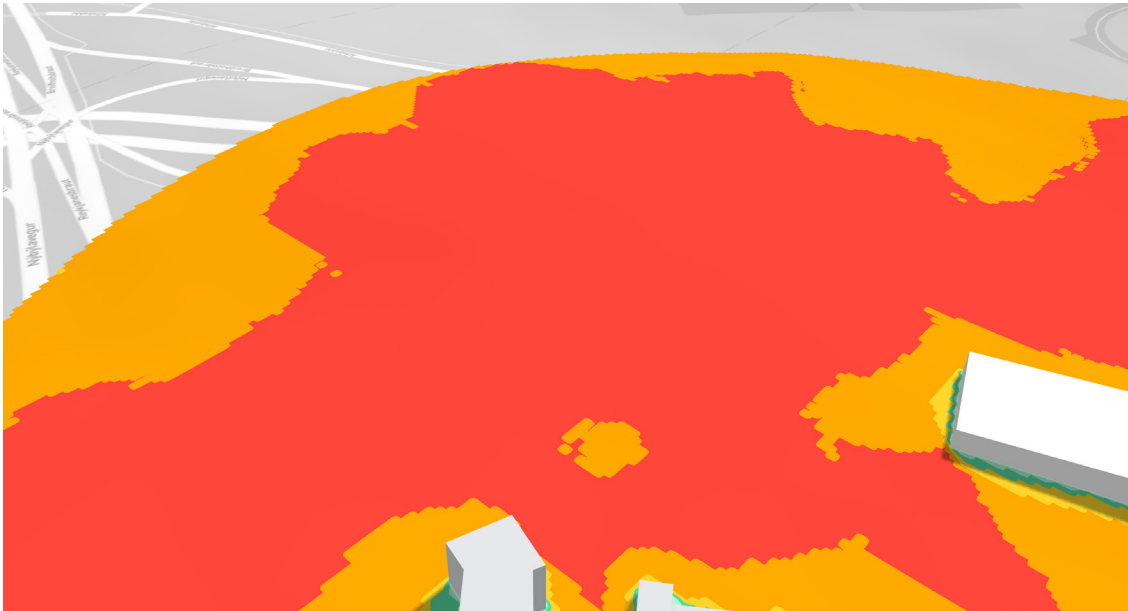
Wind analysis

Existing situation

Future situation

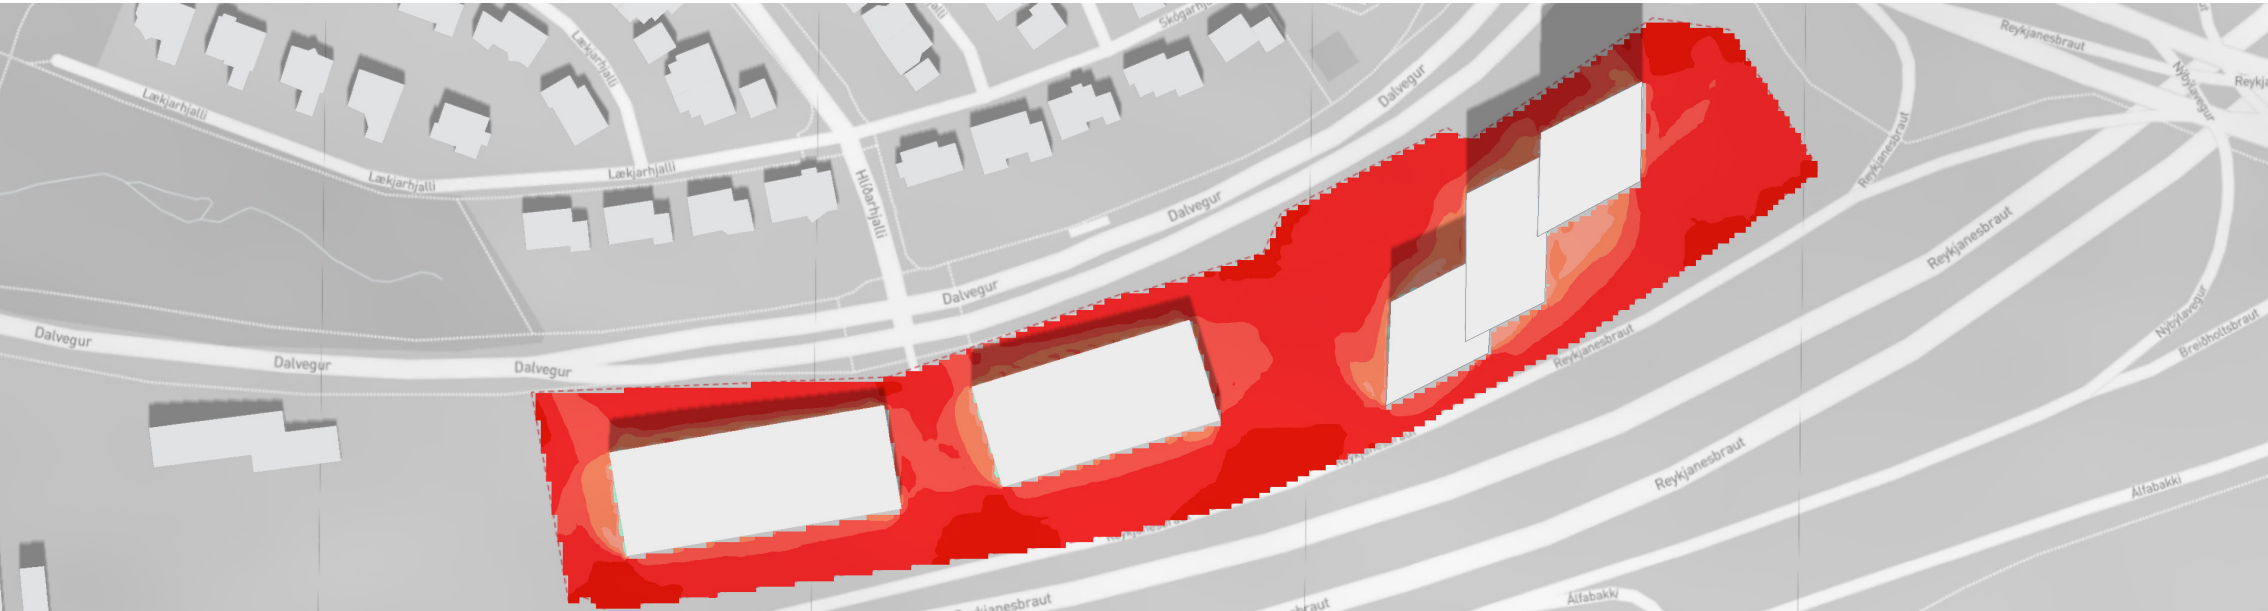
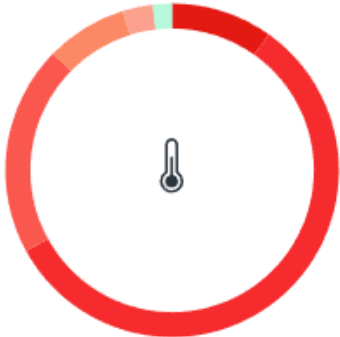
April 21

Climate comfort analysis

98 %  
2 %

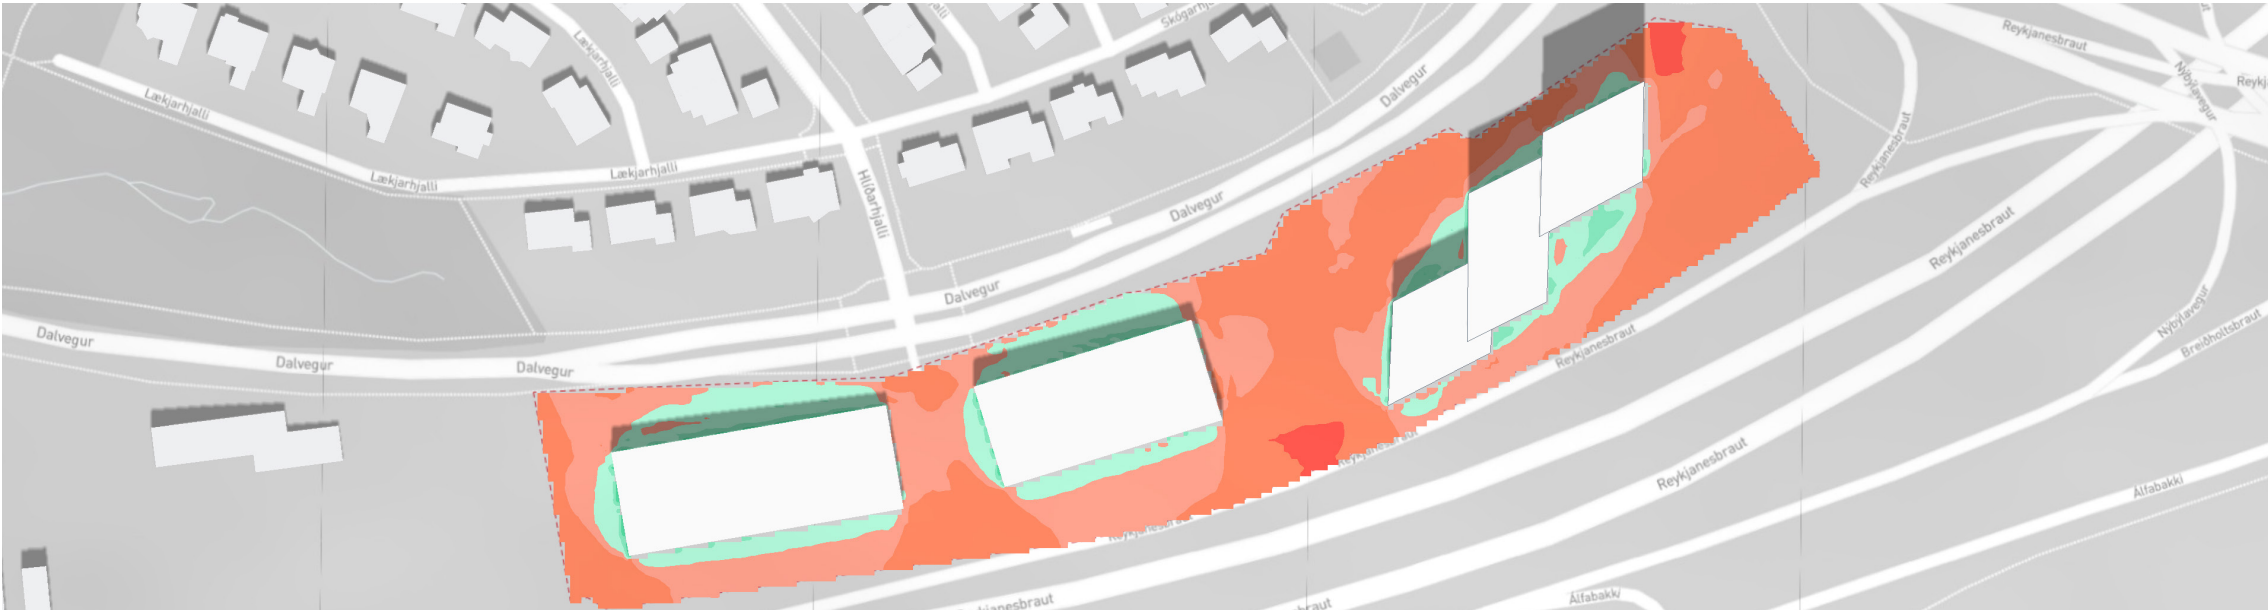
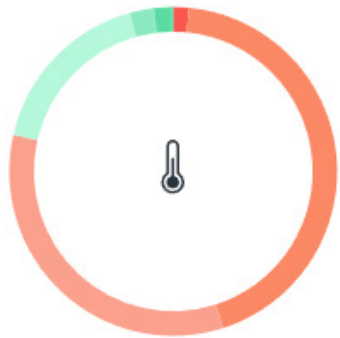
May 21

79 %  
21 %

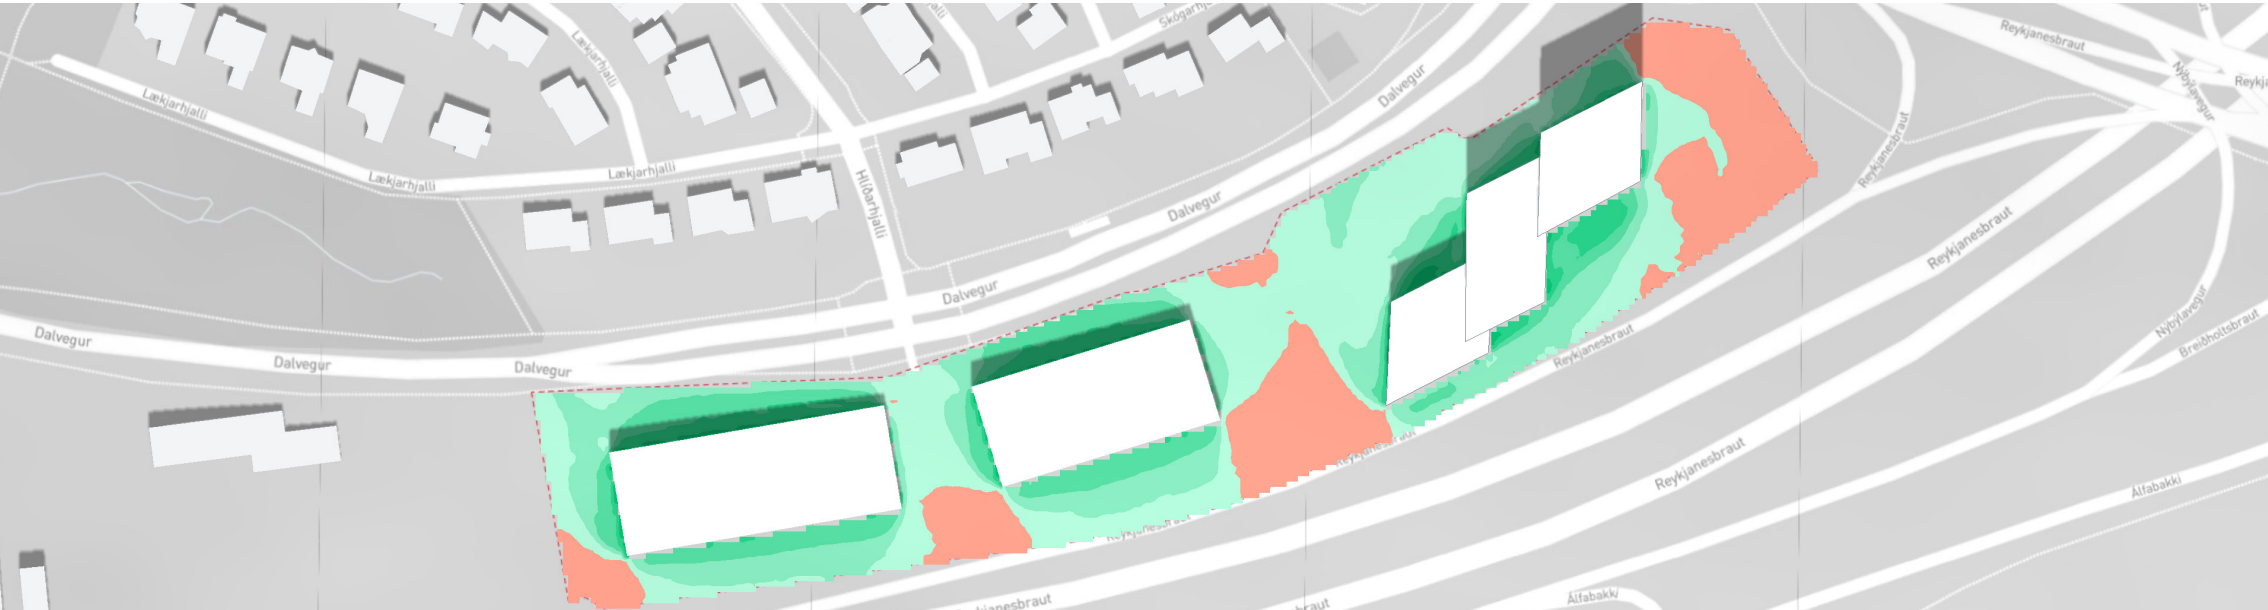
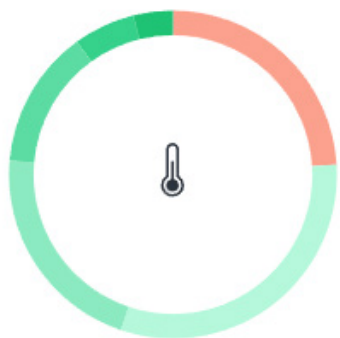
June 21

24 %  
76 %
